Inspection Report

Homegenix home inspections llc

Approximate Year Built 2022 New construction

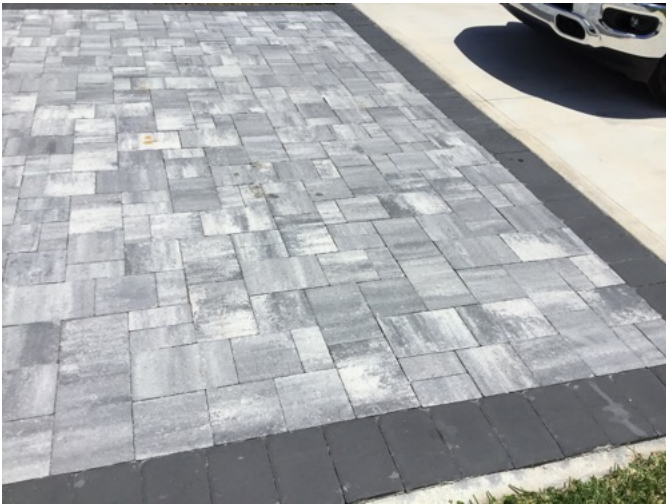
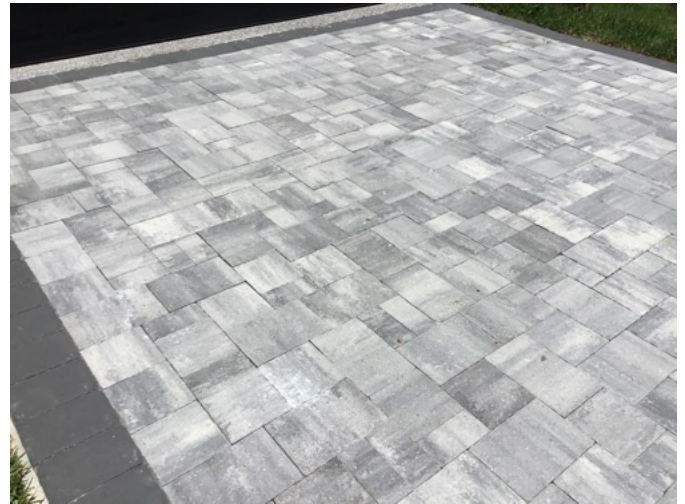
1.2) Driveway Conditions

The driveway appeared to be in serviceable condition at the time of the inspection.

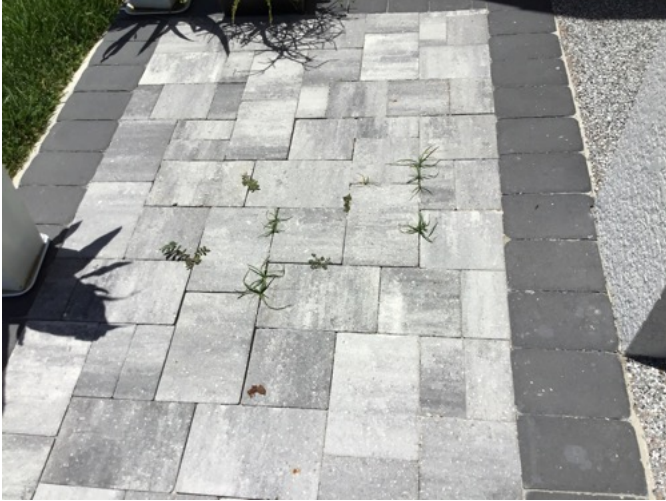
1.3) Sidewalk Conditions

Some grass in joints

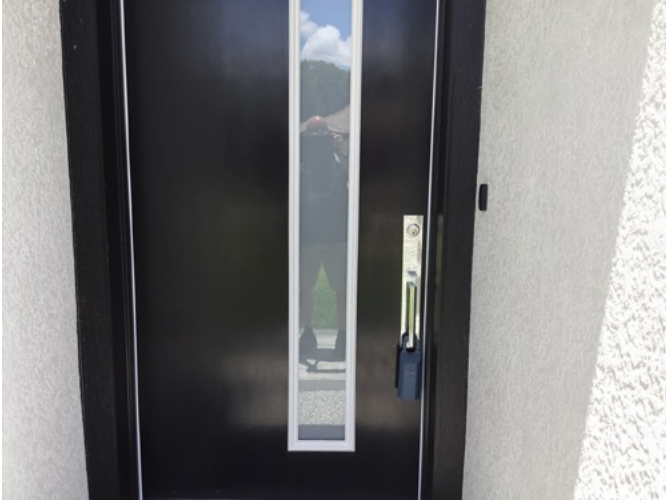
2.1) Front Entrance Conditions

The visible and accessible areas of the deck appeared to be in serviceable condition at the time of the inspection.

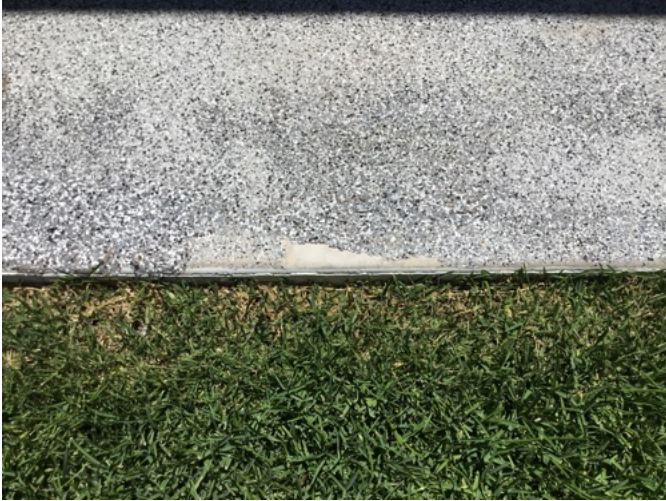
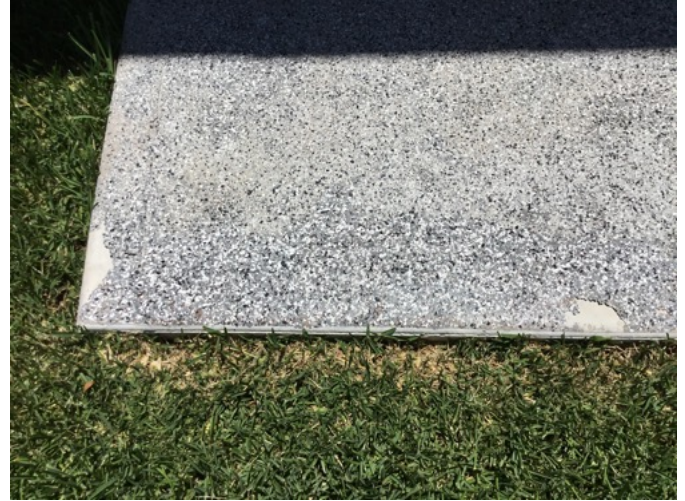
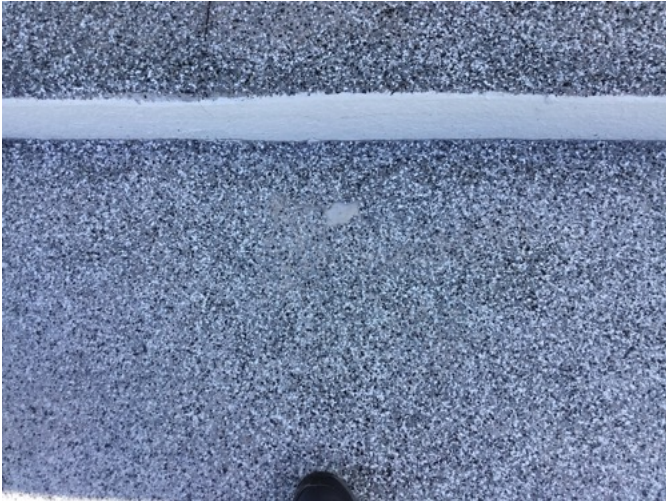
2.2) Back Entrance Conditions

Concrete finish is peeling off back patio

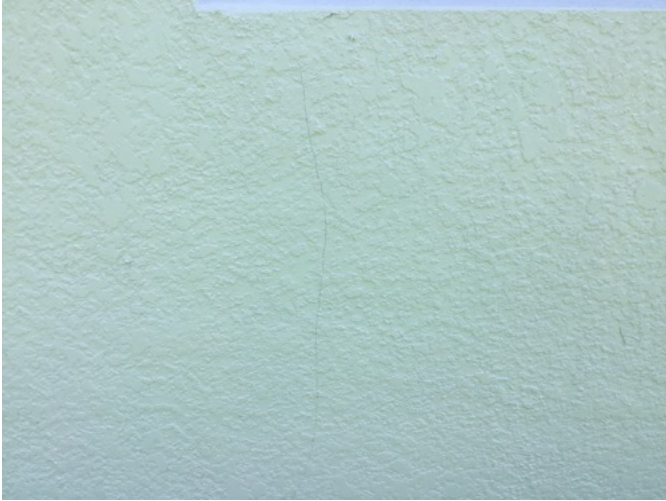
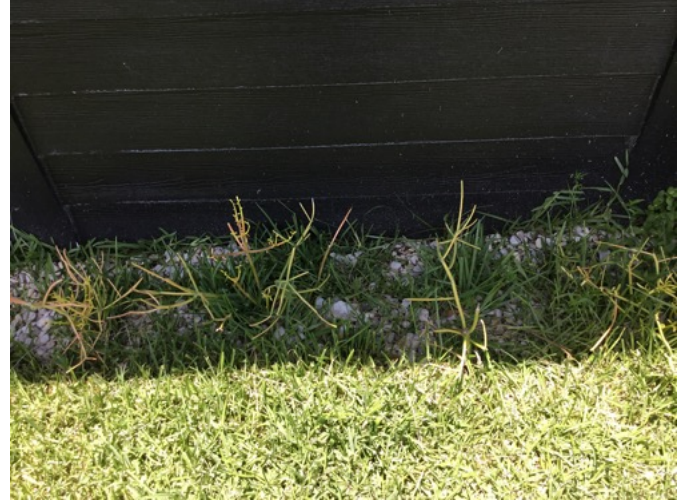
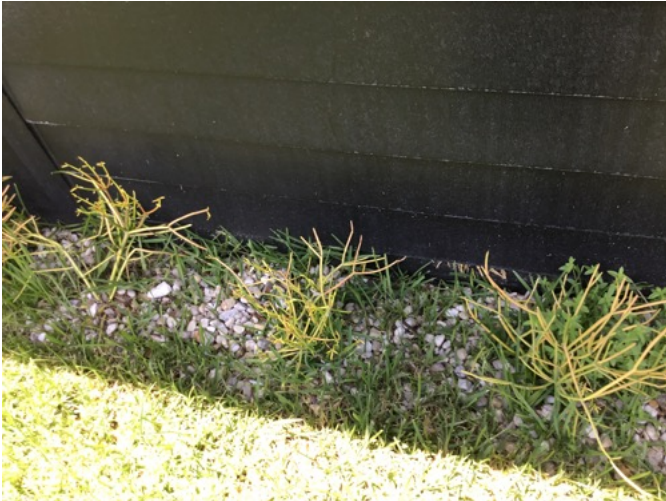
2.3) Exterior Wall Conditions

The visible and accessible portions of the exterior wall coverings appeared to be in serviceable condition at the time of the inspection. Common cracks were found in the exterior walls. Recommend sealing to reduce the possibility of water penetration. Vegetation was in contact with the exterior walls. The vegetation should be trimmed away 1 - 2 feet from the wall. The exterior walls were not fully visible due to overgrown vegetation. Siding must be 4-6 inches from the ground moisture can penetrate into the siding.

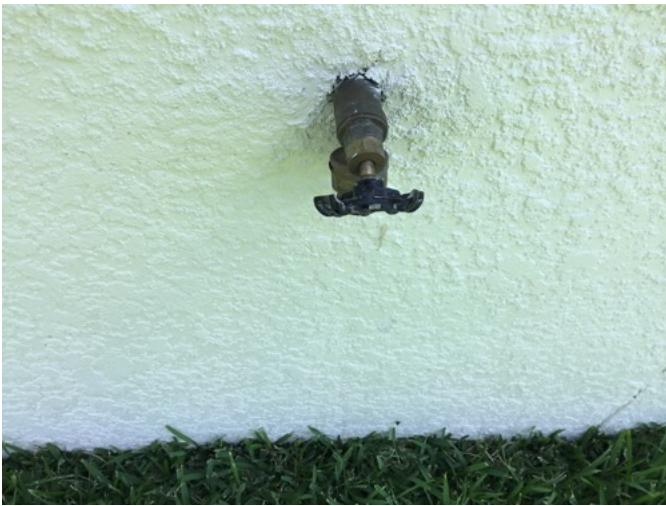
2.6) Faucet Conditions

Hose faucet had a broken or missing handle recommend repairing or replacing.

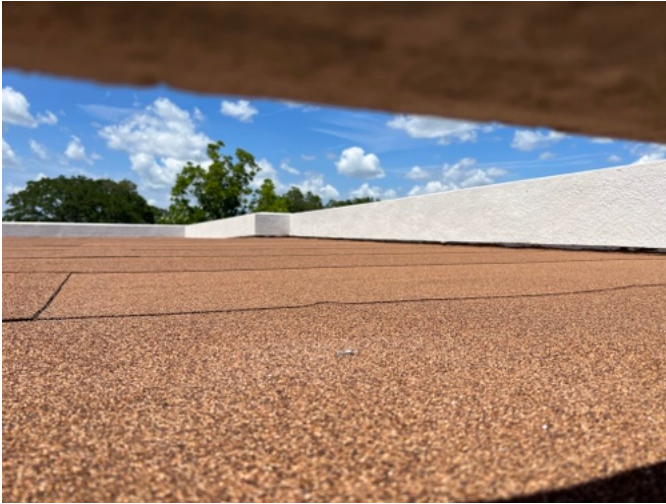
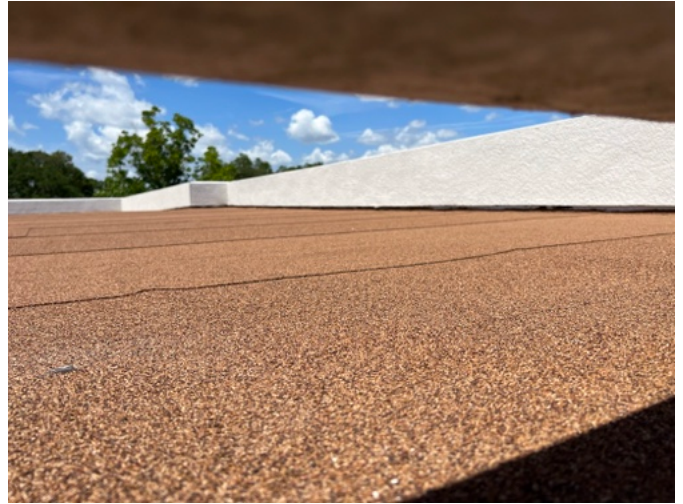
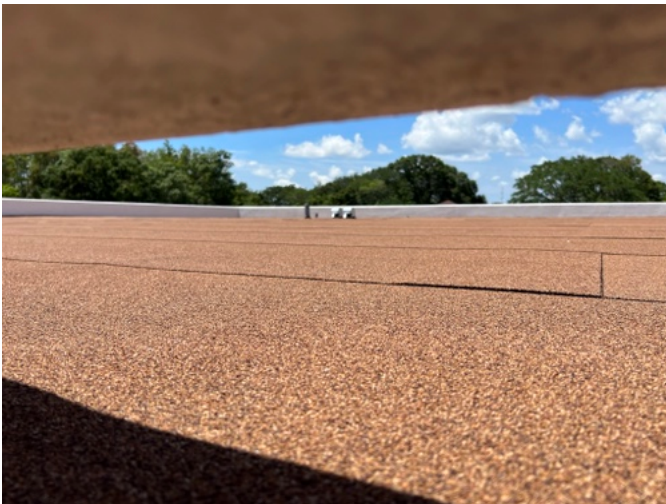
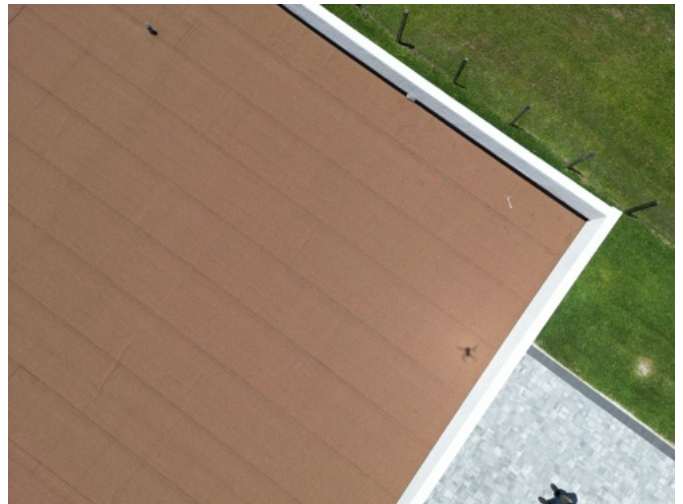
3.1) Roof Covering Condition AS

Asphalt composition shingles.

The roof covering shows normal wear for its age and appeared to be in serviceable condition at the time of the inspection.

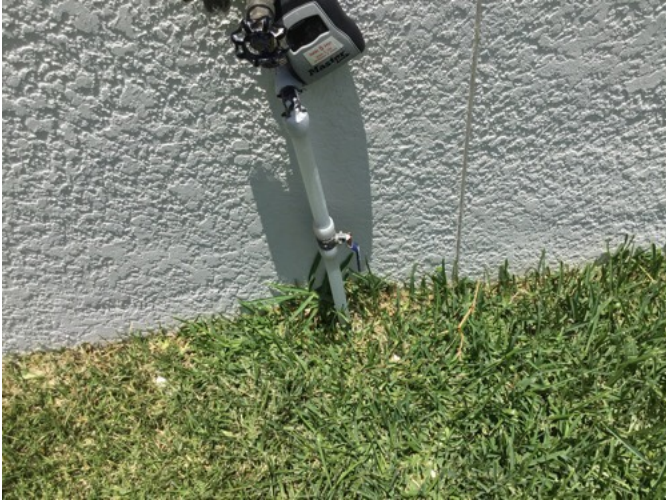
Main Shutoff Location

Side of the house

The visible material of the main line / pipe appears to be plastic.

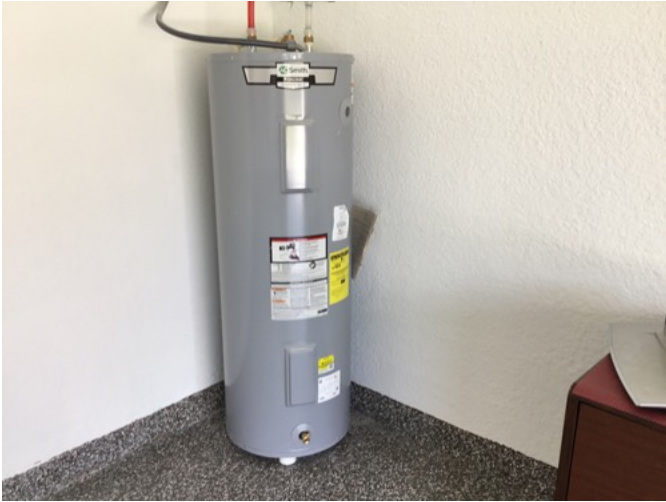
Water Heater Type Electric.

Water Heater Location Garage.

Water Heater Capacity 50 Gallon.

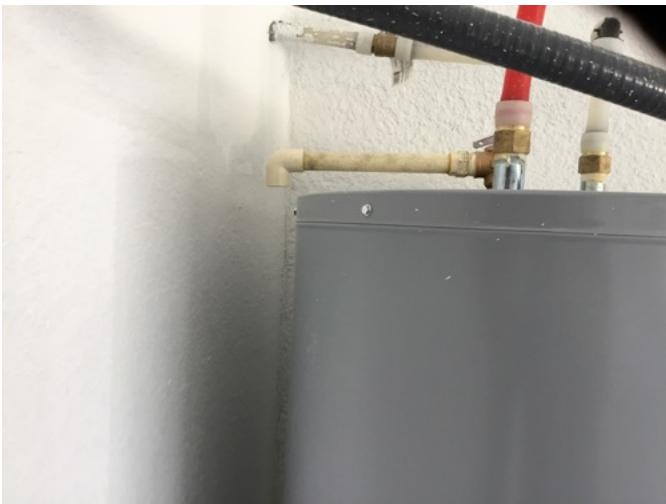
5.4) Water Heater Conditions

T P R (temperature pressure relief) valve overflow pipe too short at the time of the inspection. Recommend installation of an extension pipe 6 inches above the floor for increased safety. Client should consult a licensed plumber for additional information.

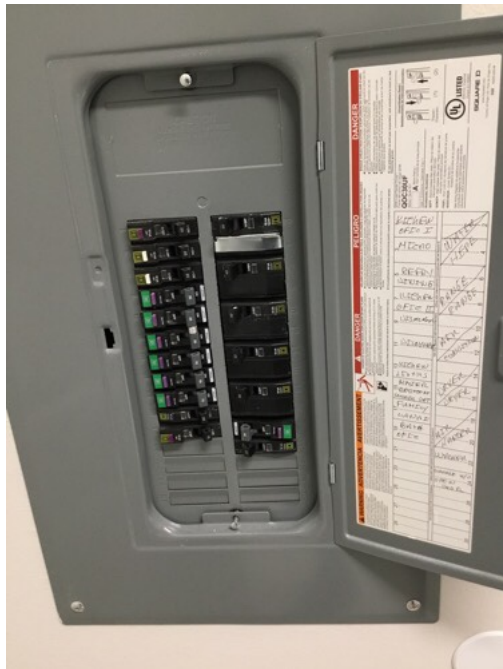
Main Electrical Panel

Main Disconnect Location	At Main Panel. Outside at meter
Electric Panel Location	The main electric panel is located at the laundry area.

Panel Amperage Rating	200
Circuit Protection Type	Breakers.
7.2) Wiring Methods	AS

The main power cable is copper. The branch cables are copper.

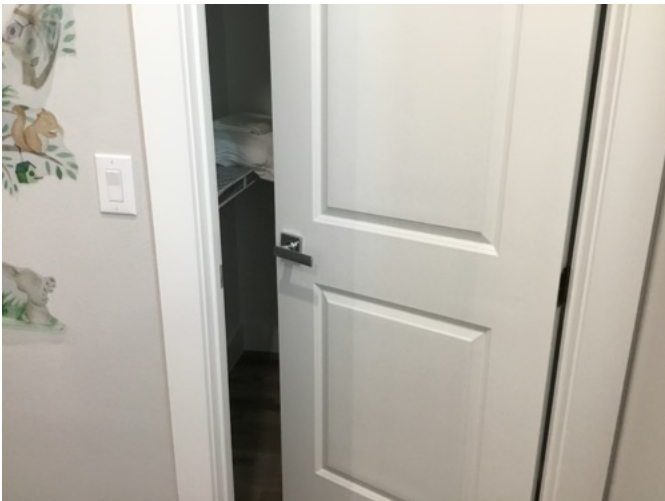
10.6) Interior Door Conditions

The closet door and bedroom door were loose or difficult to operate. Repairs and / or adjustments are recommended. Door will not latch.

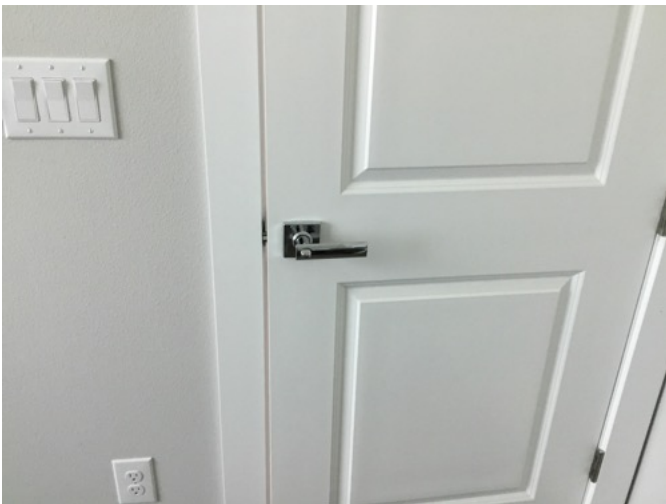
11.6) Interior Door Conditions

Door will not latch.

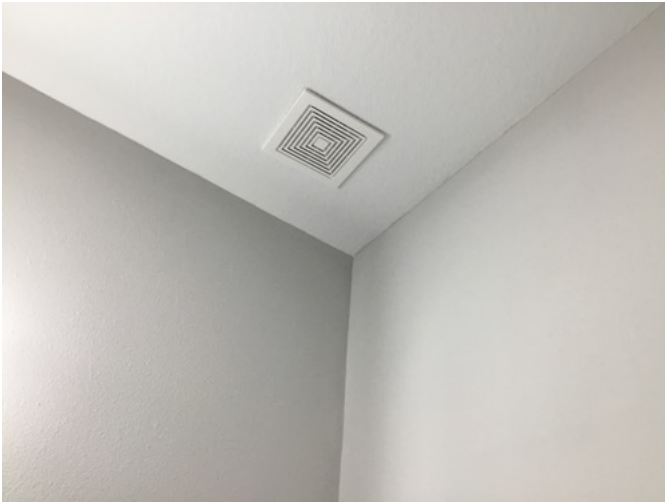
12.9) Vent Fan Conditions

The exhaust fan did not operate or was disconnected in bath . Please refer to limitations of inspection regarding mold / moisture related conditions.

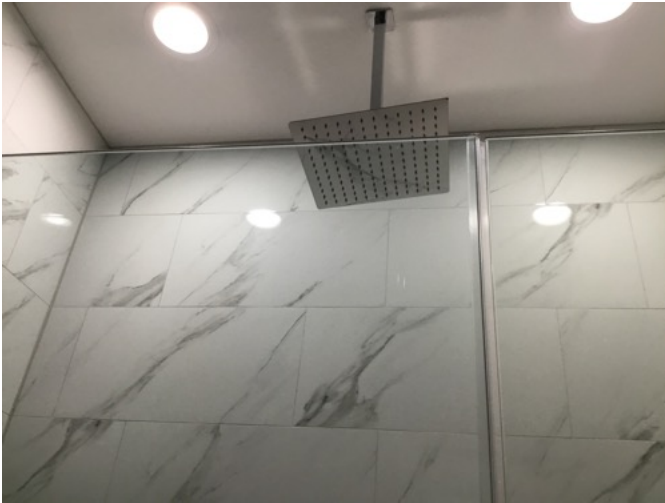
14.12) Shower - Tub Conditions

Shower head continues to drip after water was turned off. The shower drained slowly in bath . This may be an indication of a plumbing problem.
